TEST REPORT

Number of test report: A-9305/10

Name of the tested superstructure (canopy): SJS PRO-PRODUCTS pick-up loading area deck

Subject of the test: General configuration and safety inspection of loading area deck for pick-ups in N1 category

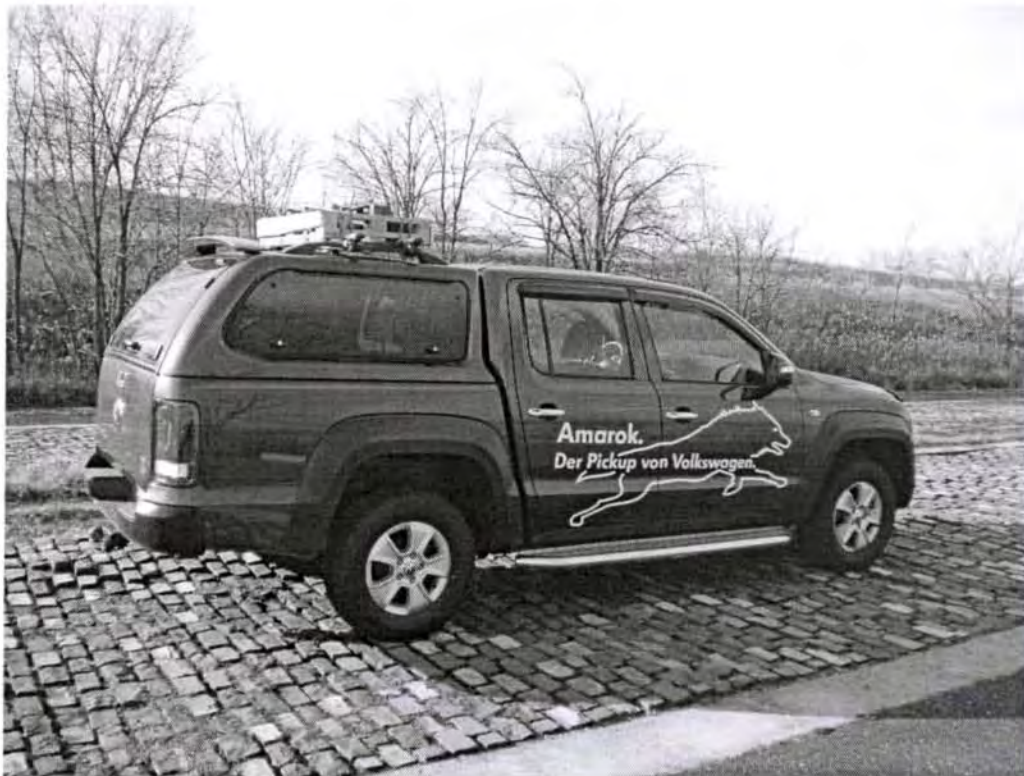
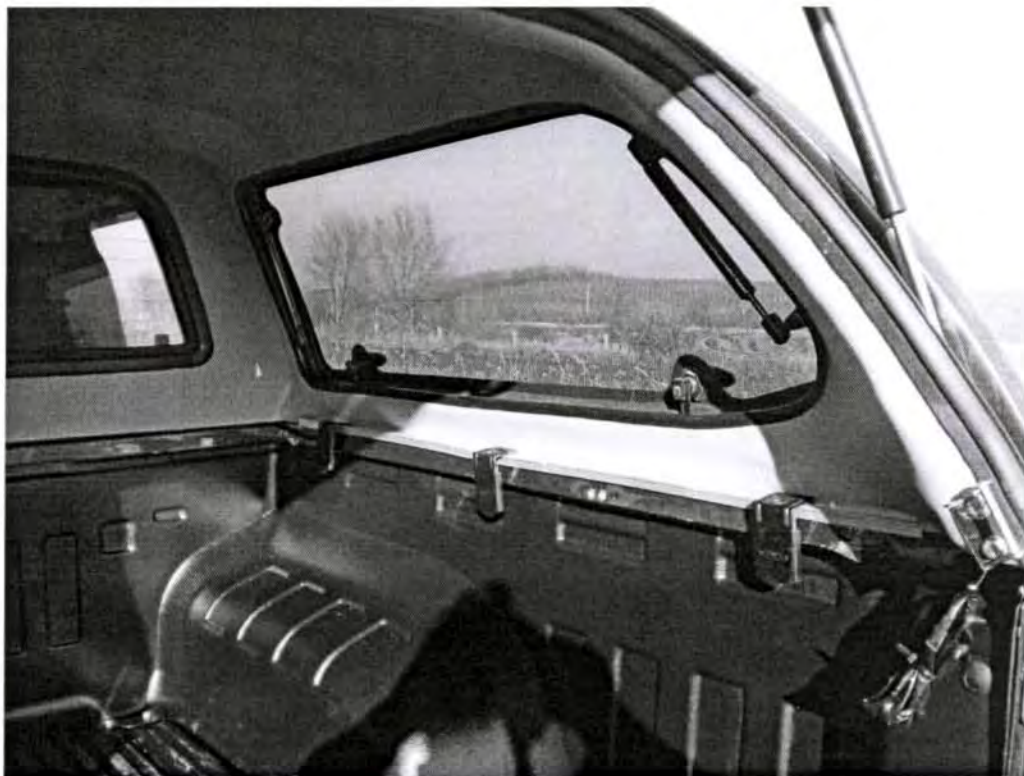
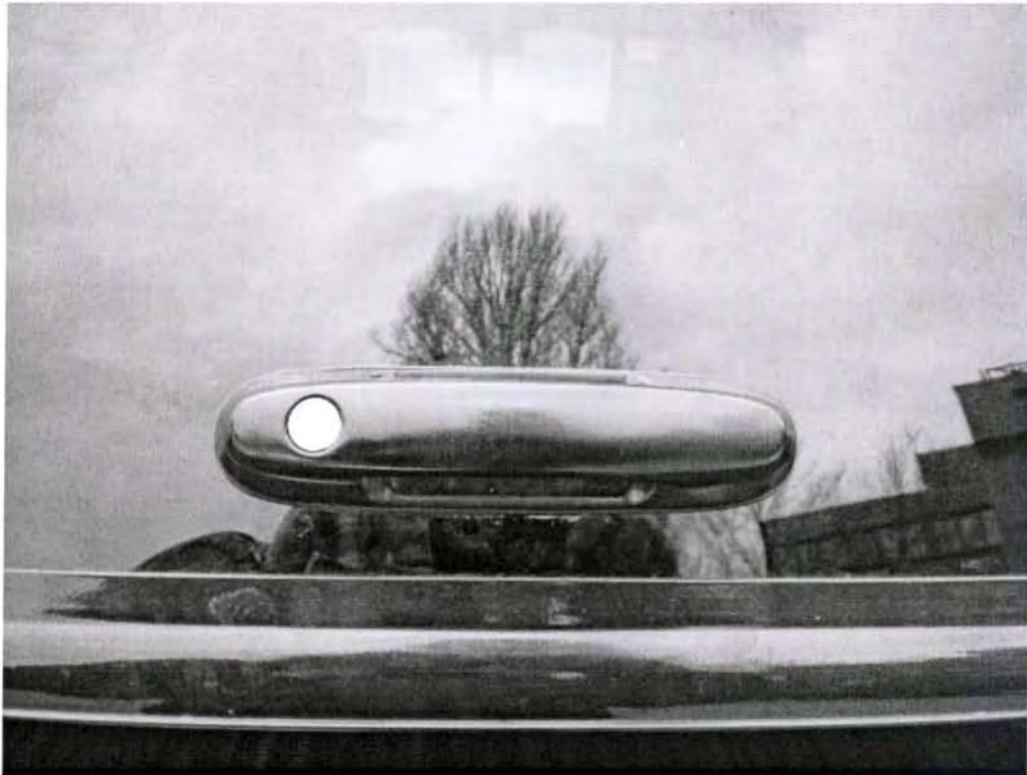
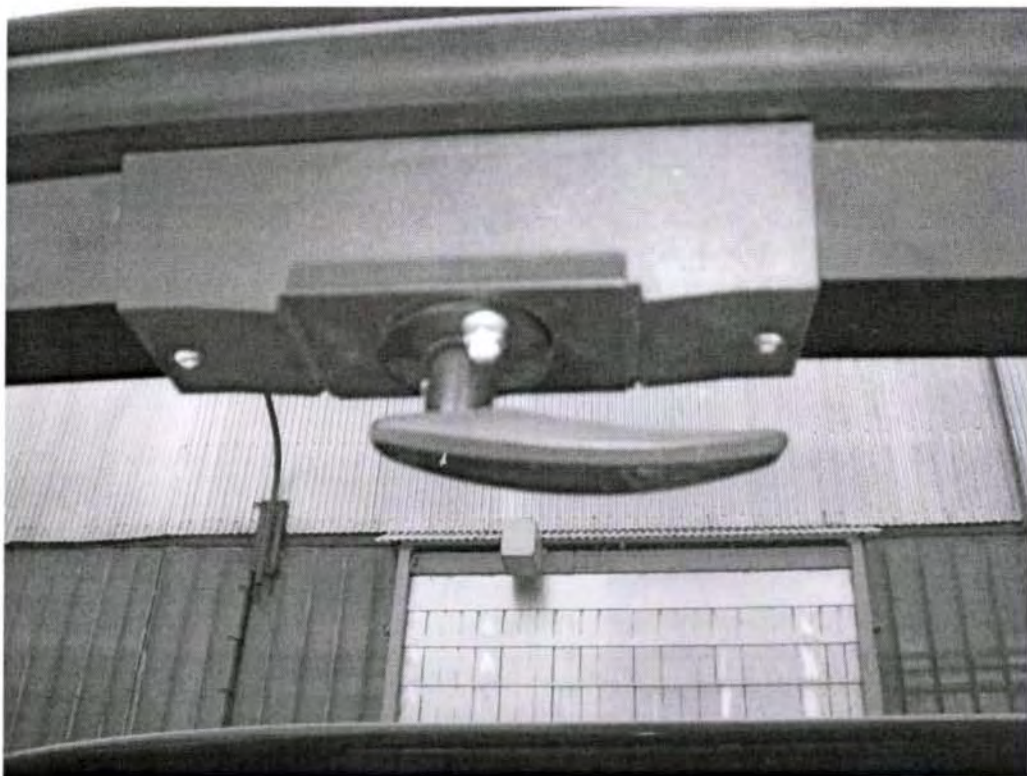
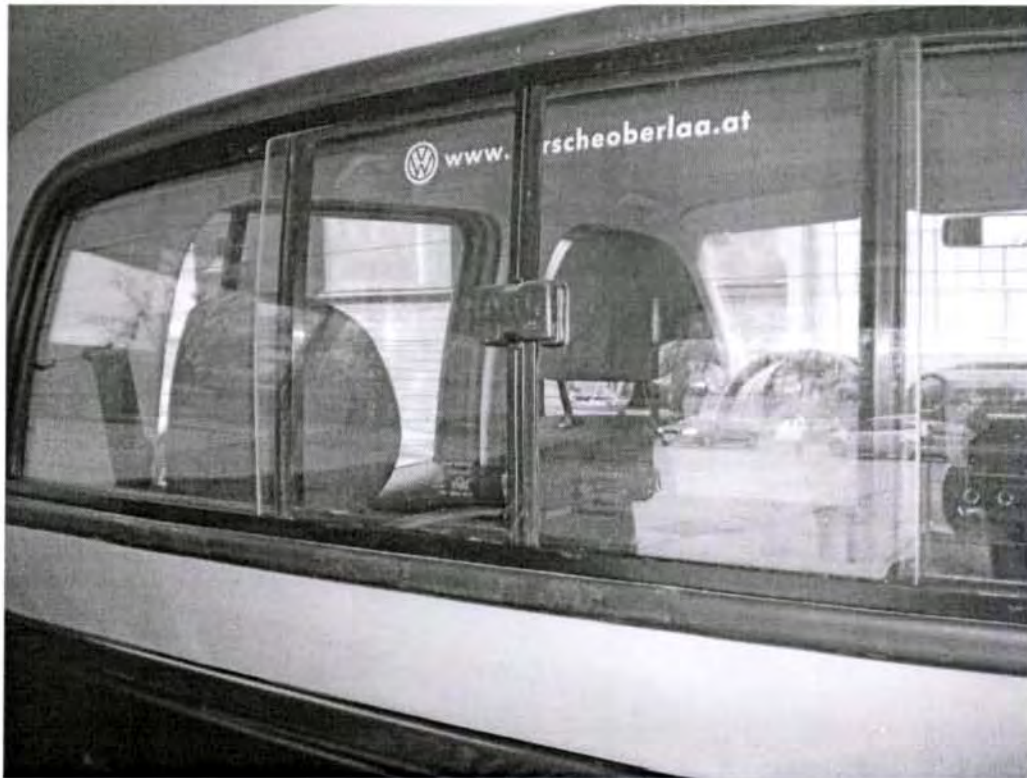
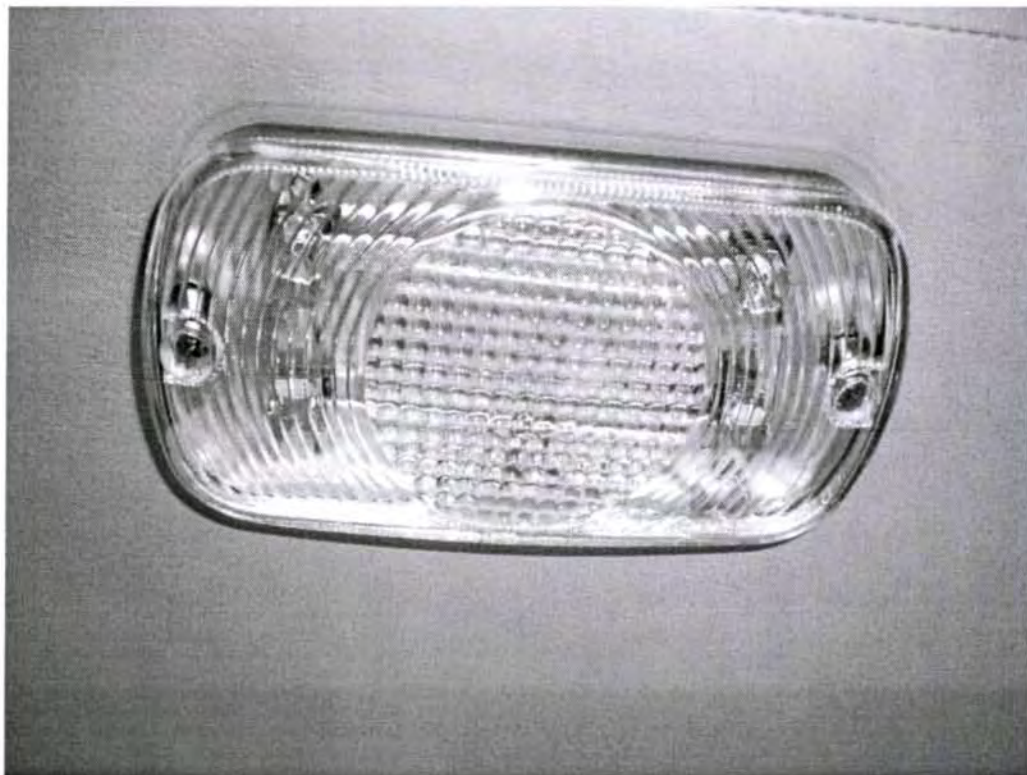
6. Photos

Its material is glass-fiber reinforced epoxy resin on the steel frame. The interior is upholstered, equipped with interior lighting that switches on, when the upper part of tailgate is opened. This door is lockable with key. There are two longitudinal rails on the top of the deck to anchoring the roof rack. The rails are firmly attached to the frame of the deck. The load capacity of the roof rack: 50 kg. The body is glazed around, there is a supplementary stop lamp the behind rear window. Two gas-springs make easier to open the upper part of the tailgate, which is opening from inside also. The body is fixed with 6 pieces of special assembly unit onto the vehicle.
